Lockheed L1011-500 Tristar, CS-TMP

AAIB Bulletin No: 10/2004	Ref: EW/C2003/08/04	Category: 1.1
Aircraft Type and Registration:	Lockheed L1011-500 Tristar, CS-TMP	
No & Type of Engines:	3 Rolls-Royce RB 211-524B turbofan engines	
Year of Manufacture:	1983	
Date & Time (UTC):	19 August 2003 at 1106 hrs	
Location:	Runway 23 at Stansted Airport, Essex	
Type of Flight:	Public Transport (Positioning)	
Persons on Board:	Crew - 13	Passengers - None
Injuries:	Crew - None	Passengers - N/A
Nature of Damage:	Scoring and deformation to underside of aft fuselage, damage to No 2 engine translating cowl and hot stream duct	
Commander's Licence:	Airline Transport Pilot's Licence and Type Rating Instructor	
Commander's Age:	54 years	
Commander's Flying Experience:	11,300 hours (of which 1,200 were on type)	
	Last 90 days - 60 hours	
	Last 28 days - 28 hours	
Information Source:	AAIB Field Investigation

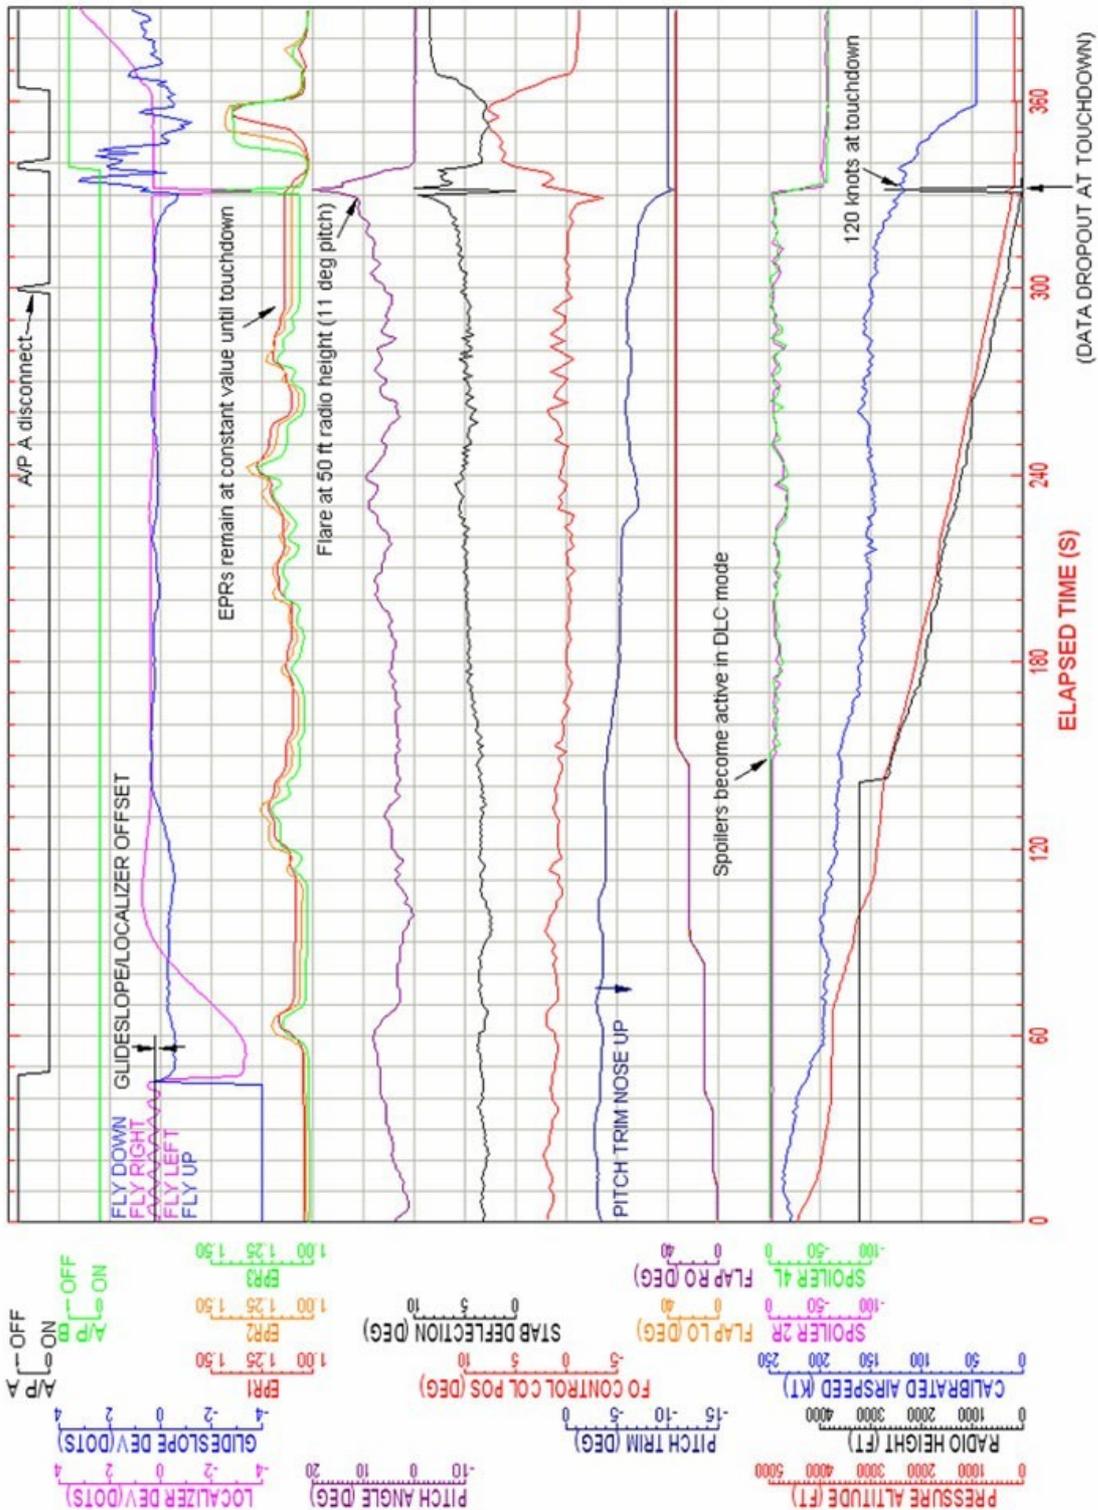
Figure 1

A time history of the relevant parameters during the landing at Stansted is shown in Figure 1. From this figure, it can be seen that A/P 'B' was already engaged when A/P 'A' was selected during the descent, at about 3,750 feet amsl, just under 5 minutes before touch down. No other distinct A/P mode discrete parameters, such as ATS or Approach/Land Mode, were available on the FDR. At A/P 'A' engagement, the localiser and glideslope deviation signals become active shortly followed by changes in the engine pressure ratios (EPRs), which had remained fairly constant at values between 1.02 and 1.05, for the previous 100 seconds. These changes in the EPRs were consistent with the ATS being active.

Salient FDR Parameters
 (Accident to CS-TMP on 19 August 2003 at Stansted Airport)

At about 30 seconds prior to touchdown, 350 feet agl, A/P 'A' disconnected and then re-engaged. From this point, the three EPRs remained fixed at values between 1.06 and 1.14 and remained at these values until touchdown. (Five seconds prior to this point, the EPRs were already at these values, following a period where the aircraft was on or above the glideslope.) Thereafter, the aircraft pitch increased, the airspeed reduced and there was an increasing divergence below the glideslope.

At 50 feet agl, four seconds before touchdown, the pitch attitude was 11° nose-up and the airspeed was 128 kt. At touchdown, the aircraft pitch attitude was in excess of 15° nose up and the recorded airspeed was 120 kt.
