Investigation & Analysis

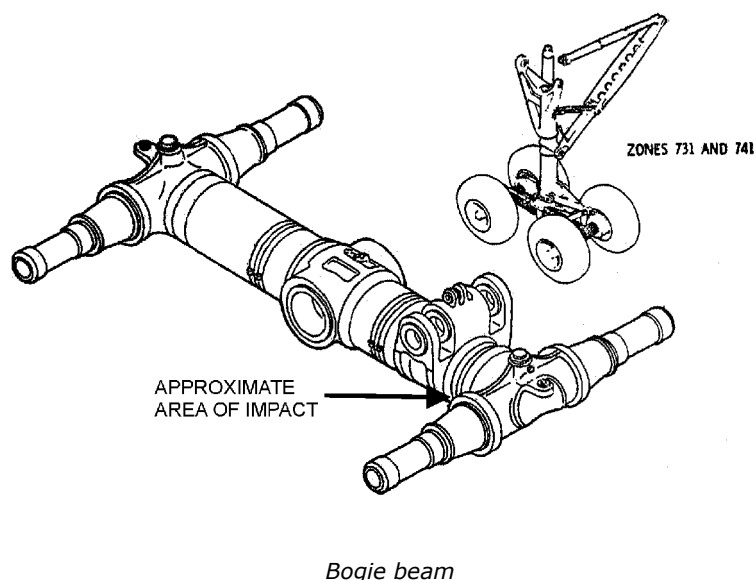
It was found that the right MLG had sustained serious damage during the rejected take-off. The brake link connection lug on its right front brake unit (see left picture) and a number of electronic and hydraulic lines of the brake- and anti-skid system of the right MLG were found broken. No other evidence of cracking was observed at that time. The four tires of the left MLG had deflated of which two tires showed large scouring spots. Three tires (two aft and one left front) of the right MLG had deflated partially. Several small parts of the right MLG were found on the runway. Subsequent to being towed from the runway, a very large crack was observed in the front part of the right MLG bogie beam (see right picture).

The fractured bogie beam was submitted to the Boeing Metallurgy Laboratory in California, USA, for fractographic evaluation. The objective of this investigation was to determine the cause of fracture of the bogie beam and to determine if any material or processing discrepancies contributed to the fracture. The following conclusions were drawn:

- Fracture of the right main landing gear bogie beam occurred due to stress corrosion cracking, which emanated from an area of mechanical damage on the right (outboard) side of the part, approximately seven inches aft of the centreline of the forward axle lug hole.
- Evidence of bubbling in the paint along the inner surface and softening of the base material along the outer surface in the area of mechanical damage, indicated that this region reached an elevated temperature.
- No material or processing defects were observed.

1. The area with mechanical damage on the bogie beam already existed before the occurrence. This damage had caused internal residual stresses in this area. The material of the bogie beam is susceptible for stress corrosion cracking. The loads on the bogie beam applied during the rejected take-off were above the stress corrosion cracking limit, causing the beam to crack. Deformations of the cracked beam caused bending at the lugs on the brake unit, resulting in fracture of them. The brake link with the free end cut the electronic and hydraulic lines of the brake and anti-skid system.

Because no material or processing defects were observed during the investigation of the bogie beam no action was taken by the Board to inform the operators who are flying with the Lockheed L-1011 Tristar, regarding the fracture of the bogie beam.

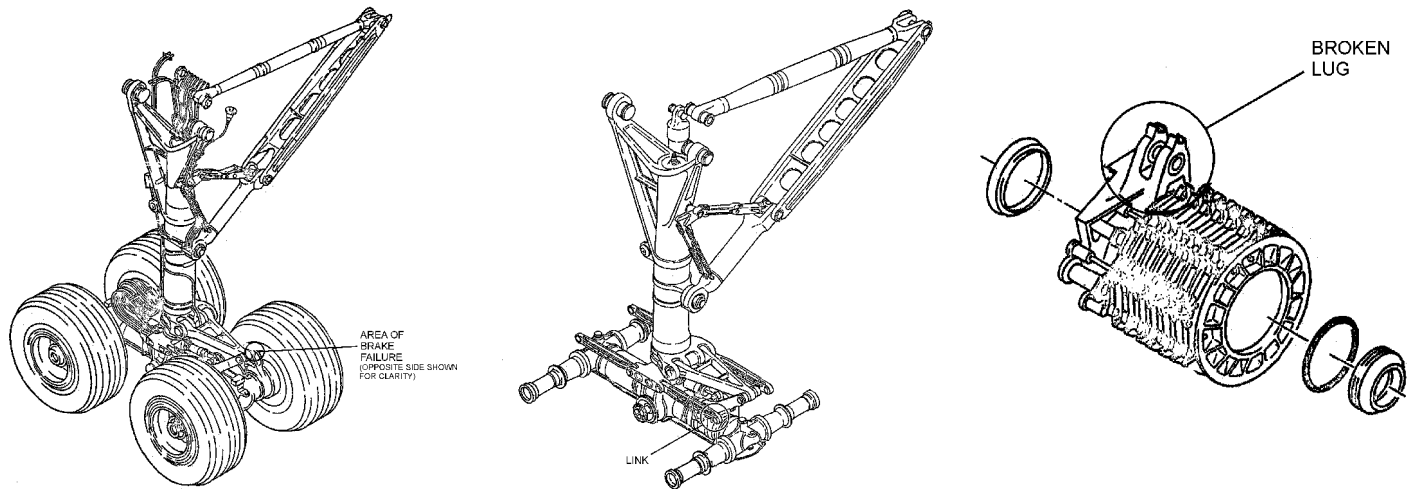
Brake link connection lug

The two detached parts of the brake link connection lug were submitted to KLM Engineering Support & Development for examination of the fractured areas. The department performed a microscopic investigation. The following conclusions were drawn by the Board:

- Investigation of fractures surfaces of the broken brake unit lug showed signs of overloading.
- At the edges some mechanical damage was present. Its cause could not be determined.

2. The lugs on the brake unit broke first. This could be a result of some pre existing deficiency in it. Too much play in the bearing, existing damage, material or processing discrepancies. As a result, the brake unit could rotate around the wheel axle. The brake link with the free end cut the electronic and hydraulic lines of the brake and anti-skid system. A small aluminium part bolted to it scrapped along the beam, smearing the soft metal on it. This process caused the damage and the heating of the damaged area. The heating reduced locally the strength of the material. Under the loads on the beam during the rejected take-off it fractured.
