The Dutch Safety Board

Occurrence #: 2004106 **Classification:** Serious incident

Date:	06-07-2004	Cockpit crew:	3
Place:	Amsterdam Airport Schiphol	Cabin crew:	12
Aircraft registration:	CS-TMR	Passengers:	314
Aircraft model:	Lockheed L-1011-385-3	Injuries:	None
	Tristar 500		
Type of aircraft:	Passenger aircraft		
Type of flight:	Commercial air transport, passenger	Lighting conditions:	Daylight
Phase of operation:	Take-off roll		
Damage to aircraft:	Serious

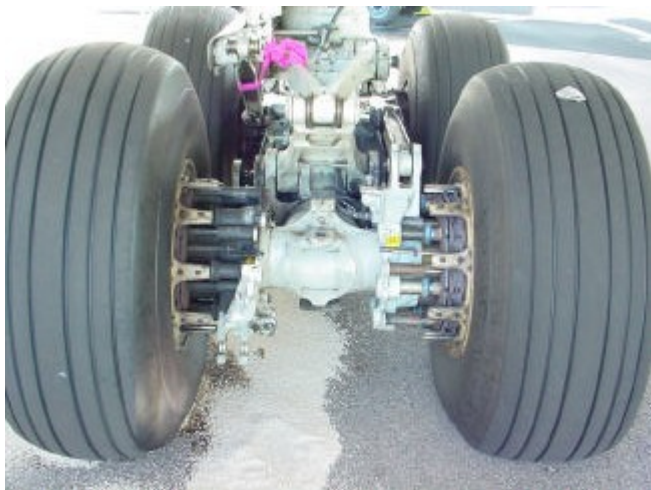
The broken lug (bottom left) of the right MLG

It was found that the right MLG had sustained serious damage during the rejected take-off. The brake link connection lug on its right front brake unit (see left picture) and a number of electronic and hydraulic lines of the brake- and anti-skid system of the right MLG were found broken. No other evidence of cracking was observed at that time. The four tires of the left MLG had deflated of which two tires showed large scouring spots. Three tires (two aft and one left front) of the right MLG had deflated partially. Several small parts of the right MLG were found on the runway. Subsequent to being towed from the runway, a very large crack was observed in the front part of the right MLG bogie beam (see right picture).

- Investigation of fractures surfaces of the broken brake unit lug showed signs of overloading.
- At the edges some mechanical damage was present. Its cause could not be determined.

Deformations of the cracked beam caused bending at the lugs on the brake unit, resulting in fracture of them. The brake link with the free end cut the electronic and hydraulic lines of the brake and anti-skid system.

2. The lugs on the brake unit broke first. This could be a result of some pre existing deficiency in it. Too much play in the bearing, existing damage, material or processing discrepancies.

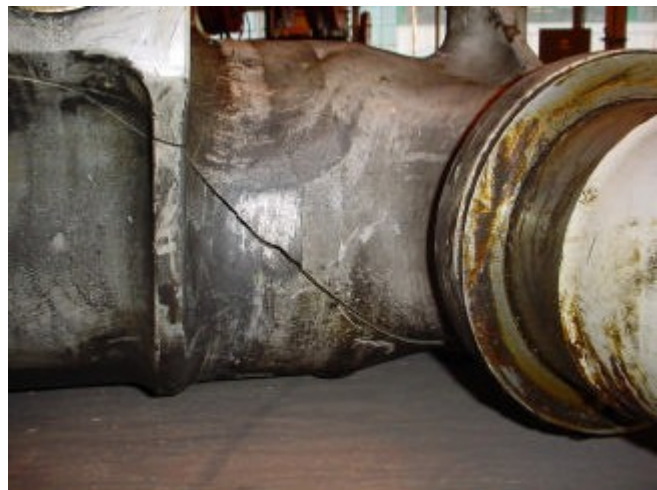
The crack in the right MLG bogie beam

- Fracture of the right main landing gear bogie beam occurred due to stress corrosion cracking, which emanated from an area of mechanical damage on the right (outboard) side of the part, approximately seven inches aft of the centreline of the forward axle lug hole.
- Evidence of bubbling in the paint along the inner surface and softening of the base material along the outer surface in the area of mechanical damage, indicated that this region reached an elevated temperature.
- No material or processing defects were observed.

1. The area with mechanical damage on the bogie beam already existed before the occurrence. This damage had caused internal residual stresses in this area. The material of the bogie beam is susceptible for stress corrosion cracking. The loads on the bogie beam applied during the rejected take-off were above the stress corrosion cracking limit, causing the beam to crack.

A small aluminium part bolted to it scrapped along the beam, smearing the soft metal on it. This process caused the damage and the heating of the damaged area. The heating reduced locally the strength of the material. Under the loads on the beam during the rejected take-off it fractured.

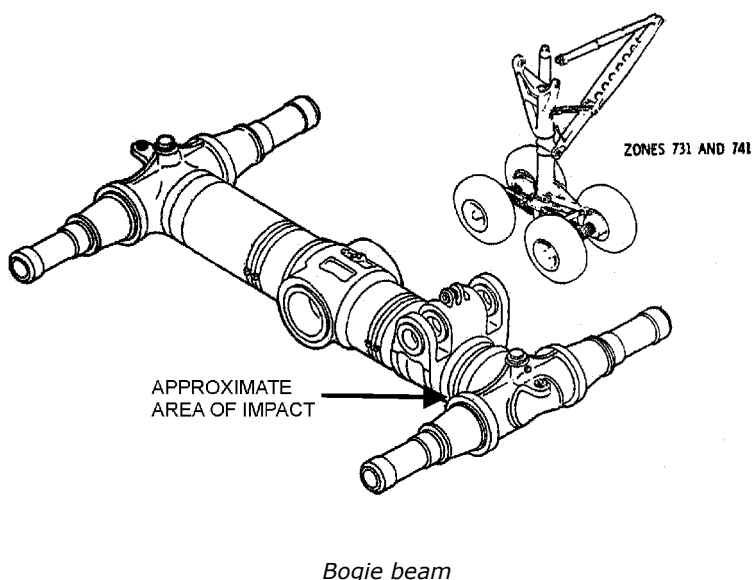
The fractured bogie beam was submitted to the Boeing Metallurgy Laboratory in California, USA, for fractographic evaluation. The objective of this investigation was to determine the cause of fracture of the bogie beam and to determine if any material or processing discrepancies contributed to the fracture. The following conclusions were drawn:

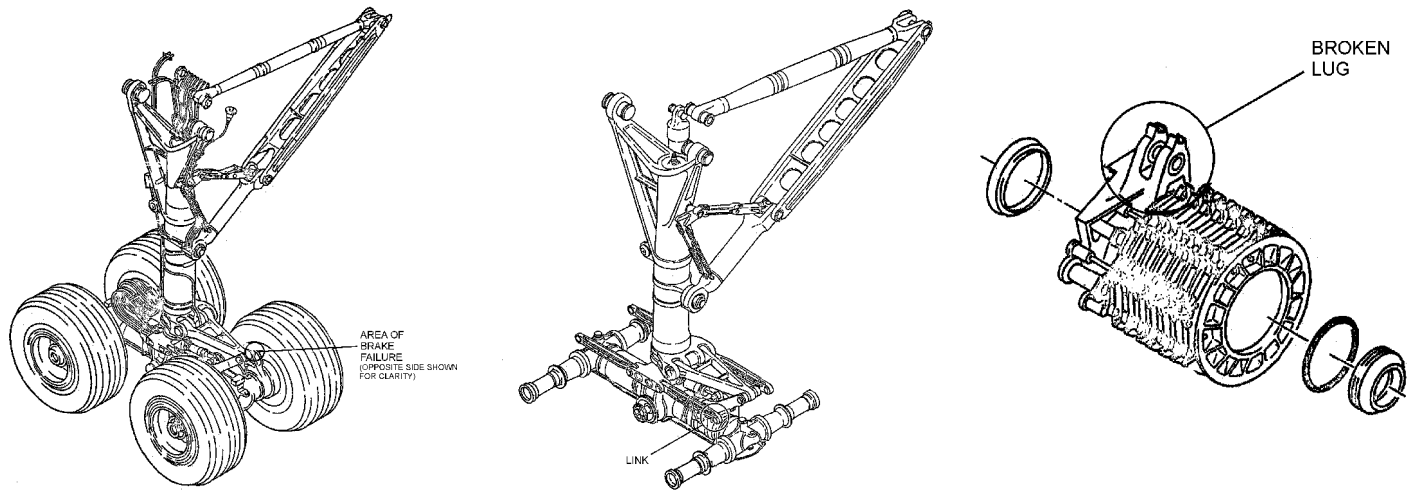
Brake link connection lug

The two detached parts of the brake link connection lug were submitted to KLM Engineering Support & Development for examination of the fractured areas. The department performed a microscopic investigation. The following conclusions were drawn by the Board:
